## **Restoration and adaptive re-use of:**

- **95 Main Street East for use as the Musée Vankleek Hill Museum**

### **95 Main Street East, Vankleek Hill**

**Restored derelict 1834 building for use as Museum, archives & visitor centre**

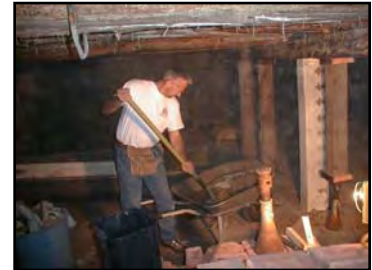
[Denis Seguin, jacks & pads]

- The goal was to install a new tin roof with 50+ years of life. The replacement cost estimate was \$15,000. Under Mr. Seguin's supervision, and with his hands-on assistance, the roofing job was completed for \$7,500 using volunteers over a two-year period.
- The ground floor required raising to a level state from a 9" sag at the centre. Jacks were borrowed and placed under supporting posts in the basement, and under Mr. Seguin's supervision slowly cranked over a two-year period.
- All the toe connections required support. Mr. Seguin added concrete pads in the basement to provide solid, long-lasting life.
- The east brick wall was damaged from years of water seepage. Local bricklayers removed, cleaned, turned and re-used the bricks. Local second-hand bricks of the same era were donated and used as replacements as needed.

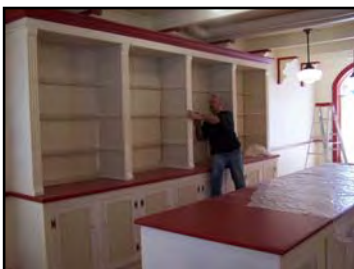
[Denis Seguin, installing completed cabinets]

Only select Eastern Ontario pine was used to refit the interior of the building as a general store. Specialty woodworkers from Eastern Ontario and Vankleek Hill were chosen to create interior milled columns, brackets, the cabinets and shelving. Missing stair rails were copied and milled. Inside, the heating and air
