Restoration and adaptive re-use of:

- **95 Main Street East for use as the Musée Vankleek Hill Museum**

95 Main Street East, Vankleek Hill

Restored derelict 1834 building for use as Museum, archives & visitor centre

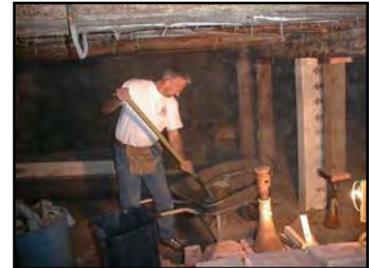
[Denis Seguin, jacks & pads]

- The goal was to install a new tin roof with 50+ years of life. The replacement cost estimate was \$15,000. Under Mr. Seguin's supervision, and with his hands-on assistance, the roofing job was completed for \$7,500 using volunteers over a two-year period.
- The ground floor required raising to a level state from a 9" sag at the centre. Jacks were borrowed and placed under supporting posts in the basement, and under Mr. Seguin's supervision slowly cranked over a two-year period.
- All the toe connections required support. Mr. Seguin added concrete pads in the basement to provide solid, long-lasting life.
- The east brick wall was damaged from years of water seepage. Local bricklayers removed, cleaned, turned and re-used the bricks. Local second-hand bricks of the same era were donated and used as replacements as needed.

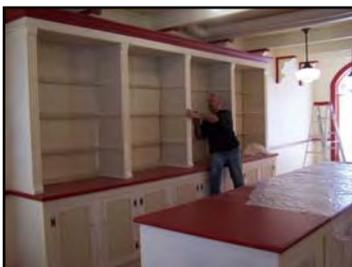
[Denis Seguin, installing completed cabinets]

Only select Eastern Ontario pine was used to refit the interior of the building as a general store. Specialty woodworkers from Eastern Ontario and Vankleek Hill were chosen to create interior milled columns, brackets, the cabinets and shelving. Missing stair rails were copied and milled. Inside, the heating and air
